## PR1147 / PR1180

### Technical Advice

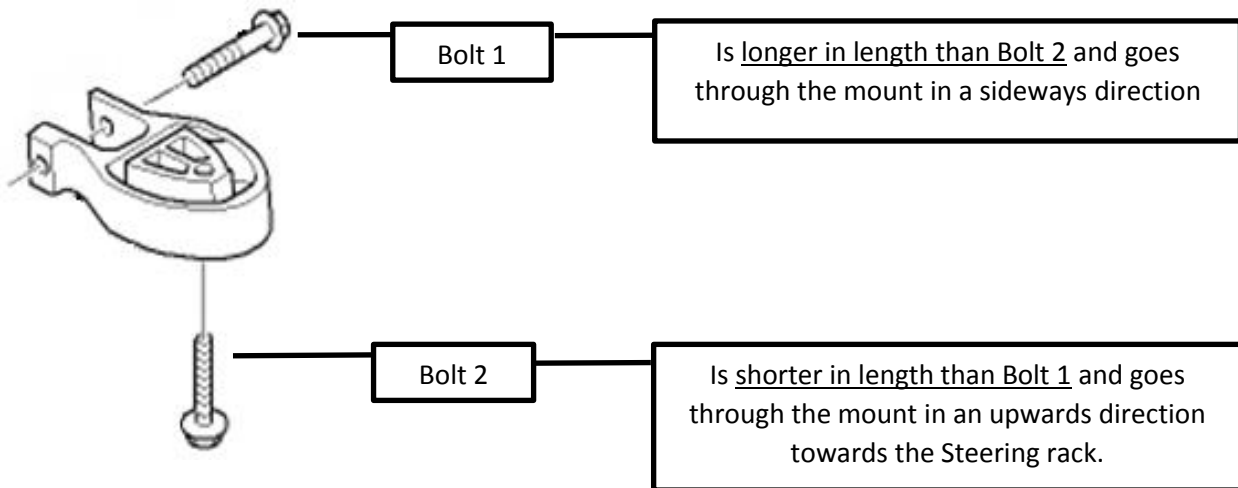
As part of the fitment process for PR1147 & PR1180 the front subframe is lowered or removed. This involves removing the lower gear box mounting (please see Fig 1 below).

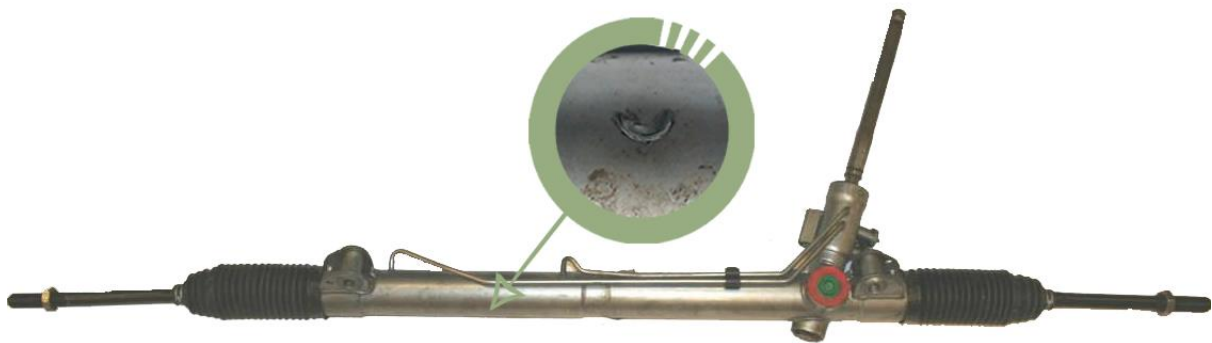
The two bolts securing the lower gear box mounting are noticeably different in length. Please pay extra attention when re-installing the bolts, as failure to insert the correct bolt in the correct location will result in irreparable cast damage to the steering rack. This damage will invalidate the warranty. (please see Fig 2 below).

**\*\*Please note this type of cast damage will result in a Surcharge Rejection\*\***
